MAJOR ORIENTATION-ERROR ACCIDENTS IN REGULAR ARMY UH-1  
AIRCRAFT DURING FISCAL YEAR 1968: ACCIDENT FACTORS

W. Carroll Hixson, Jorma I. Niven, and Emil Spezia

U. S. ARMY AEROMEDICAL RESEARCH LABORATORY  
NAVAL AEROSPACE MEDICAL RESEARCH LABORATORY

October 1971

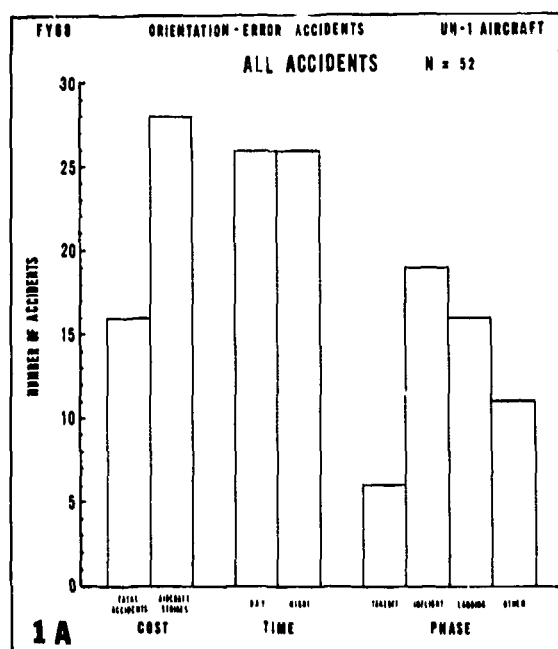
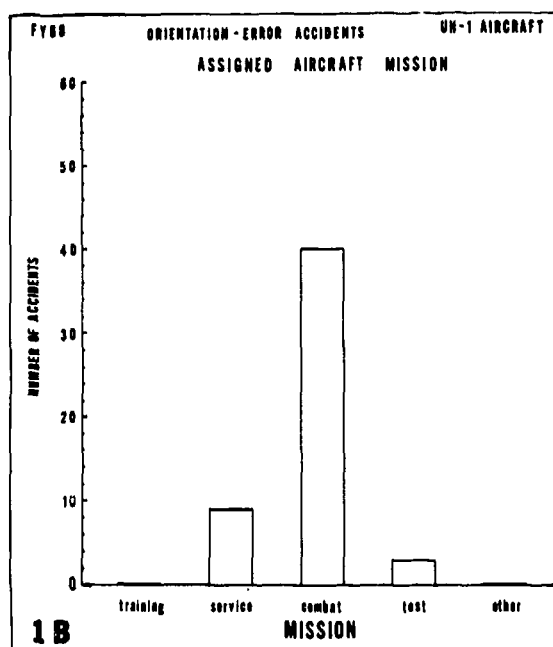
Figure 1

As indicated by the cost data presented in Figure 1A, the hazard of the orientation-error class of accidents was considerable for that fiscal year. Some 30.8 percent of the accidents were fatal, while 53.8 percent resulted in a total loss of the aircraft. The time-of-day data indicate an equal incidence for day and night accidents. In terms of the phase of flight in which the accident occurred, 36.5 percent of the accidents occurred during the inflight phase, 30.8 percent during the landing phase, 21.1 percent during the "other" phase, and 11.5 percent during the takeoff phase. It should be noted that the "other" phase classification used in this report denotes localized operations, such as reparking an aircraft, lifting a sling load, or moving an aircraft to a nearby refueling site.

Major orientation-error accidents occurring in Regular Army UH-1 aircraft during fiscal year 1968. Number of fatal accidents, number of aircraft strikes, time of day of the accidents, and the flight phase in which the accident occurred (A); and types of missions assigned to the accident aircraft (B).

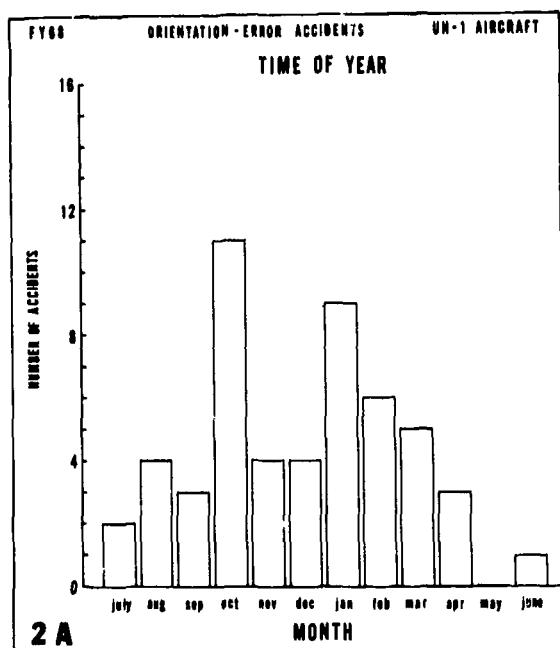
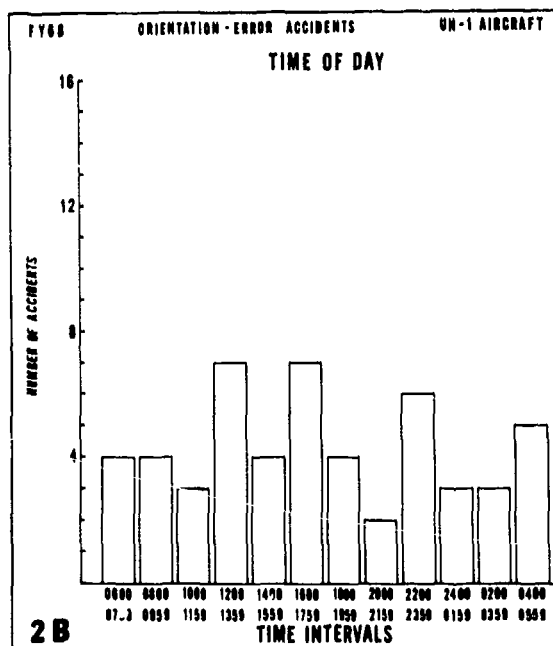
Figure 2

In Figure 2A a distribution is given of the number of accidents during each month of the fiscal year. Since the majority of the accidents occurred in Vietnam, the time-of-year incidence of accidents due to weather and dust peaked in that country's monsoon and dust seasons, respectively. Interpretation of these data beyond this point is restricted by the month-to-month variations in the level of combat operations being conducted at a given time. Similarly, the daily variation in frequency of operations would affect interpretation of the hourly distribution data plotted in Figure 2B, which shows accident incidence in 2-hour increments over a 24-hour period.

Number of orientation-error accidents as a function of the time of year (A) and the local time of day (B).

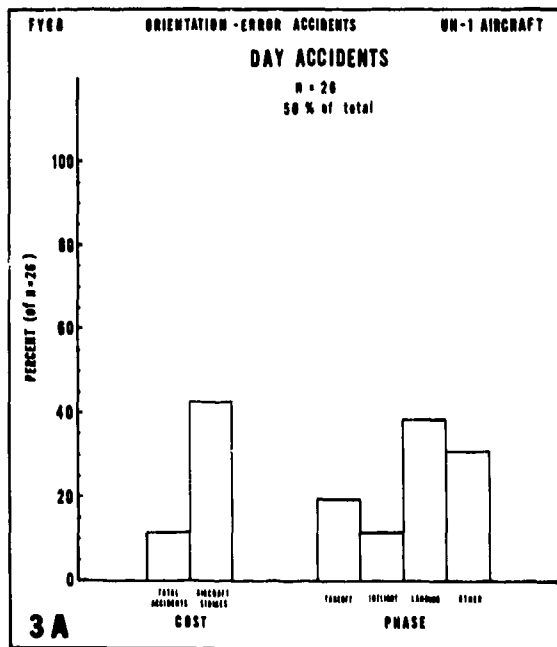
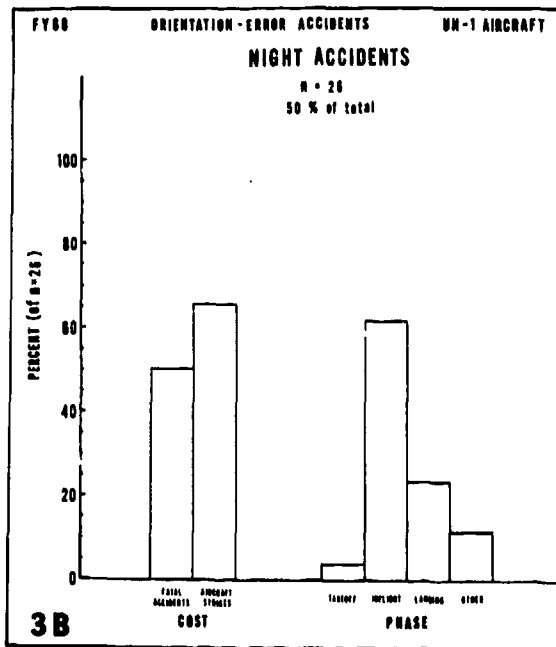
Figure 3

Additional data related to the time-of-day incidence of the orientation-error accidents are presented in Figure 3. Statistics pertaining to the 26 accidents that occurred under daylight visibility conditions are plotted in Figure 3A. Similar data for the 26 night accidents are shown in Figure 3B. It is obvious that the cost of night accidents in

Comparison of percent incidence of fatal accidents, aircraft strikes, and flight phases for the 26 orientation-error accidents that occurred under daylight visibility conditions (A) and the 26 accidents that occurred under night visibility conditions (B). Note the considerably greater hazard of the night flights.

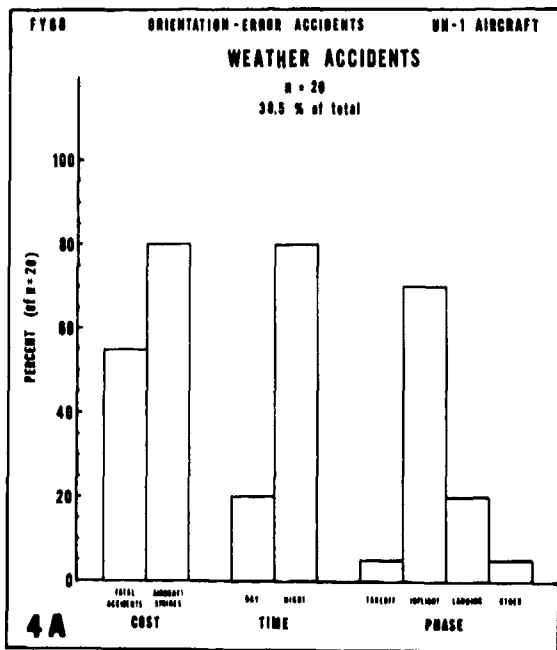
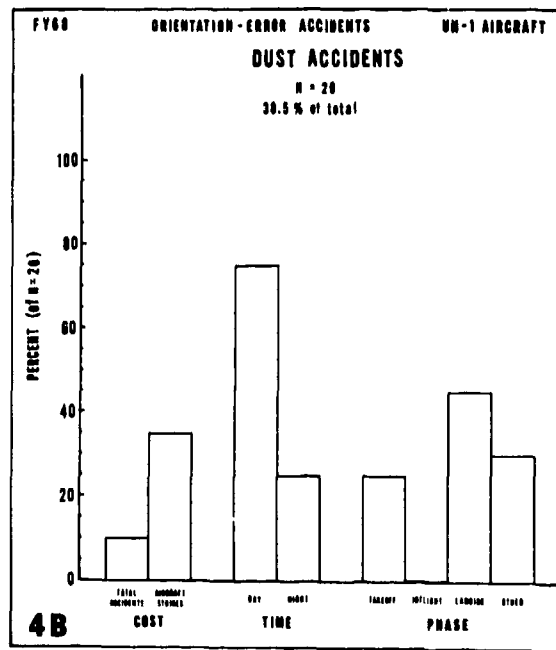
Figure 4

Comparison of percent incidence of fatal accidents, aircraft strikes, day/night accidents, and phases of flight for the 20 orientation-error accidents that involved poor weather (A), and the 20 accidents that involved rotor-raised ground dust or ashes (B). Note the high incidence of fatal accidents and aircraft strikes involved in the weather accidents.

Data pertaining to accidents involving degraded visibility due to weather and rotor-raised ground dust are presented in Figure 4. As denoted in Figure 4A, poor weather of one form or another was present in 20 (38.5 percent) of the 52 orientation-error accidents. The hazard of these weather accidents was most significant since 55.0 percent of the accidents were fatal and 80.0 percent resulted in aircraft strikes. A further significant feature was that the majority (80.0 percent) of the accidents occurred at night. Of the 16 accidents that occurred under these special conditions, i.e., visibility degraded both by weather and by darkness, 10 (62.5 percent) were fatal. Of the four weather accidents that occurred during daylight, only one was fatal. With respect to the total of 11 fatal weather accidents, 10 (90.9 percent) of these occurred at night. In terms of the phase of flight when the accident occurred, the inflight phase had the greatest incidence (70.0 percent).

As indicated in Figure 4B, an additional 20 (38.5 percent) of the 52 orientation-error accidents involved degraded visibility due to rotor-raised ground dust. Though there were only two fatal accidents in this classification, a considerable number (35.0 percent) involved the total loss or strike of the aircraft. In contradistinction to the weather accident data, the majority (75.0 percent) of the dust accidents occurred under daylight visibility conditions. Relative to the phase of flight, landing accidents had the greatest incidence (45.0 percent) followed by the "other" and takeoff phases.

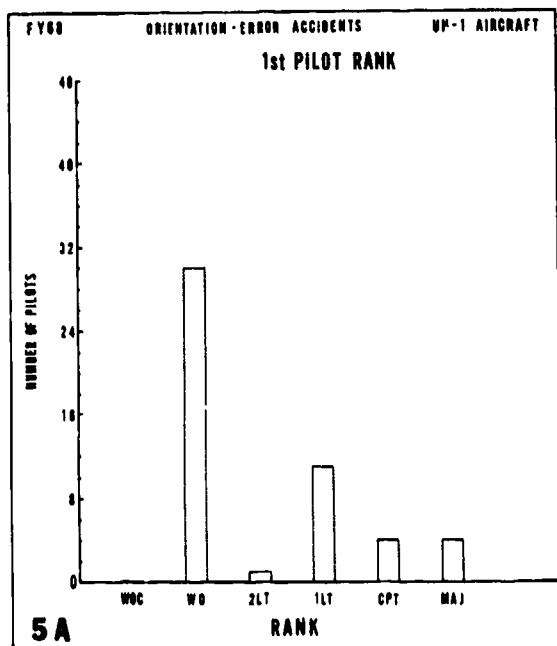
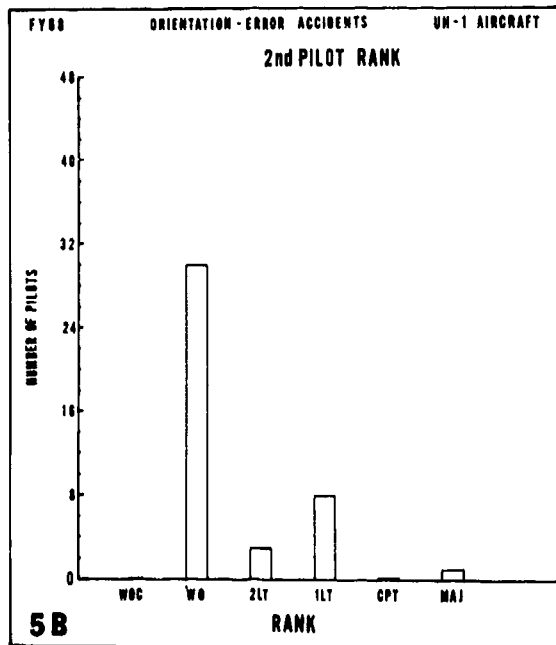
Figure 5

Data pertaining to the military rank of the first and second pilots are shown in Figures 5A and 5B, respectively. Of the 50 first pilots for whom rank data were

Distribution by rank of 50 first pilots (A) and 42 second pilots (B) involved in the orientation-error accidents. As explained in the text, the first pilot notation is used to describe the commanding aviator aboard the aircraft. In general, for Vietnam accidents, the first pilot is the "air commander" and the second pilot is the "pilot." For accidents occurring elsewhere, the first and second pilot notation usually corresponds to the conventional "pilot" and "copilot" designations, respectively.

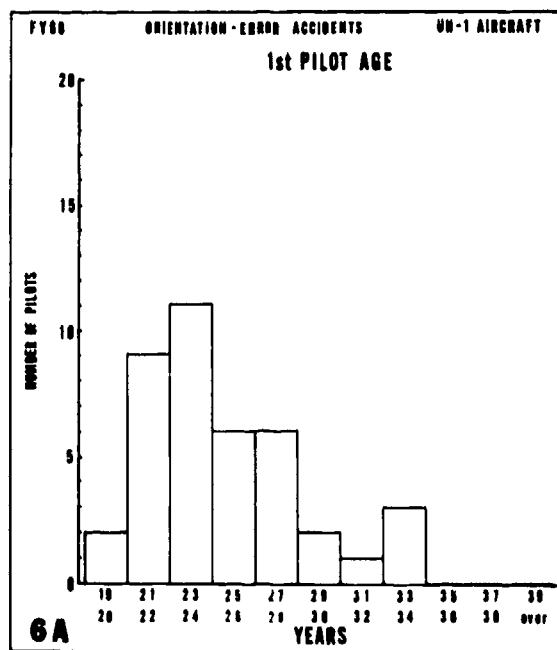
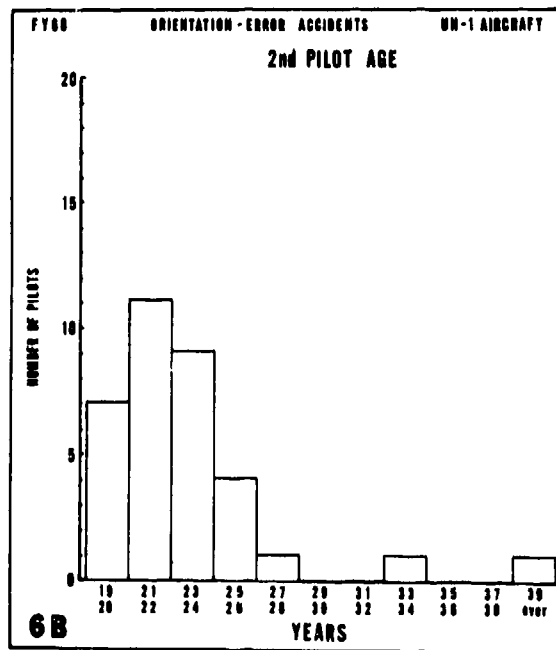
Figure 6

Age distribution of the first pilots (A) and second pilots (B). The median ages were approximately 23.6 years and 21.8 years, respectively.

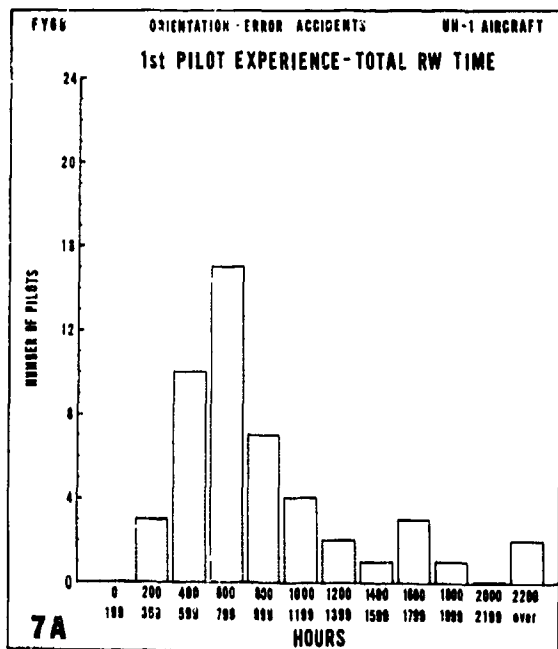
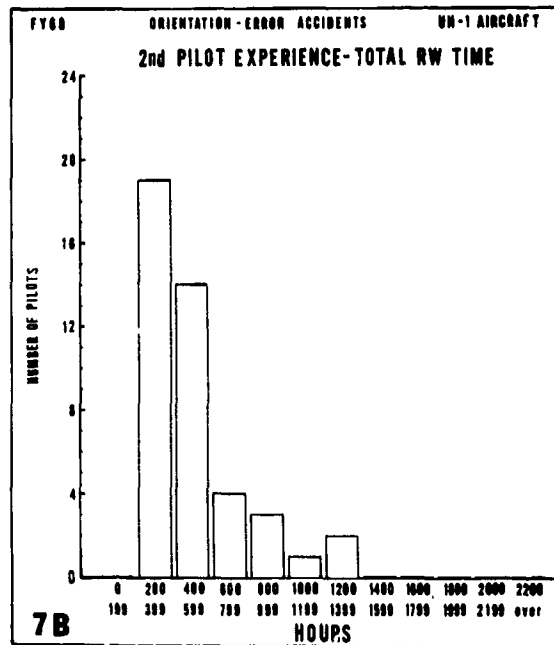
Figure 7

Distribution of total flight hours experience in military rotary-wing aircraft of the first pilots (A) and second pilots (B). The medians were approximately 747 hours and 436 hours, respectively. These data do not include any additional fixed-wing experience. (See Figure 10 for related FW and RW experience data.)

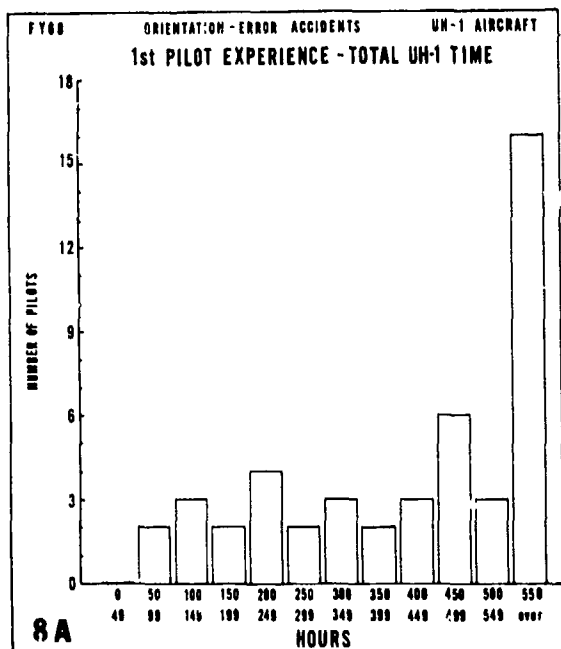
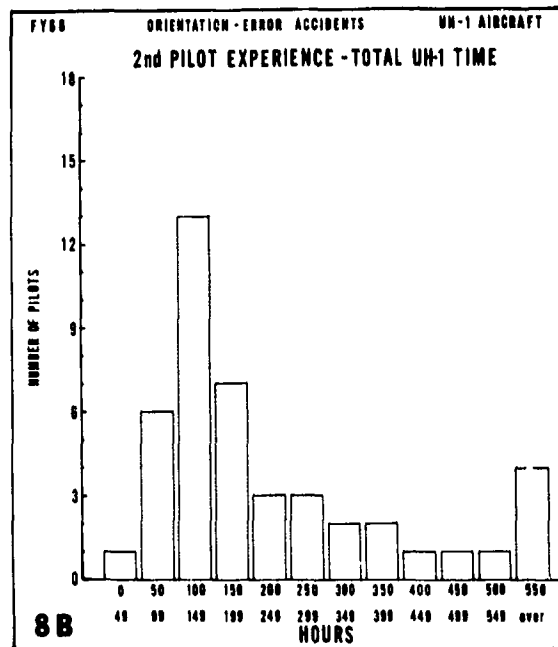
Figure 8

Distribution of total flight hours in the UH-1 aircraft of the first pilots (A) and second pilots (B). The median times were approximately 467 hours and 164 hours, respectively. (See Figure 10 for related UH-1 experience data.)

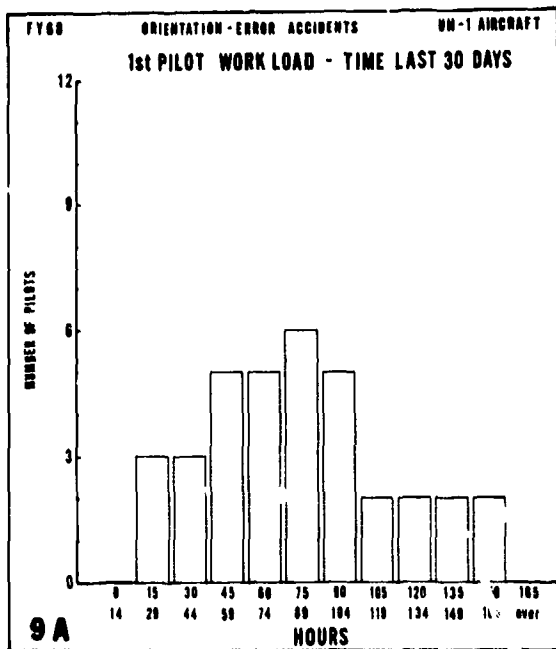
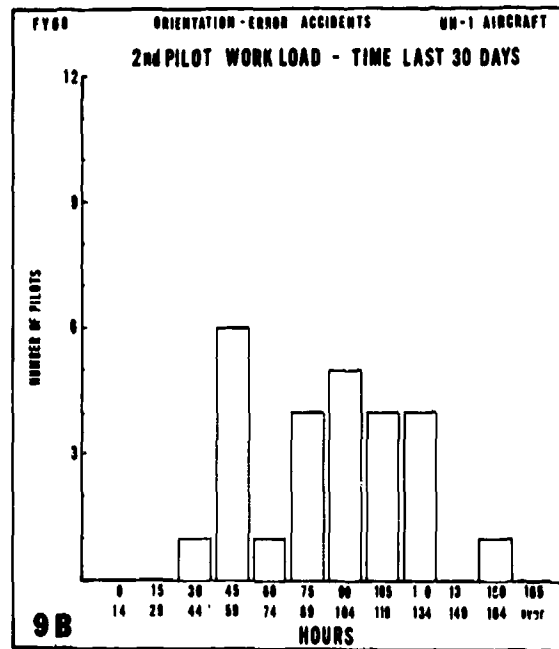
Figure 9

Distribution of pilot workload in terms of the total number of hours flown the 30 days preceding the accident by the first pilot (A) and the second pilot (B). The median workloads were 79 hours and 93 hours, respectively. (See Figure 10 for related fatigue listings.)
